Manhole Inspection Summary

Manhole # S37YY_022MH

Insp Date: **12/28/06 9:25 AM**

Location Address: **3109 BRENTWOOD AVE**

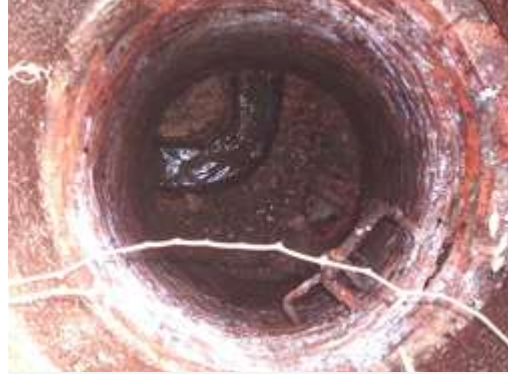
Top View

Corroded steps. Bench debris.

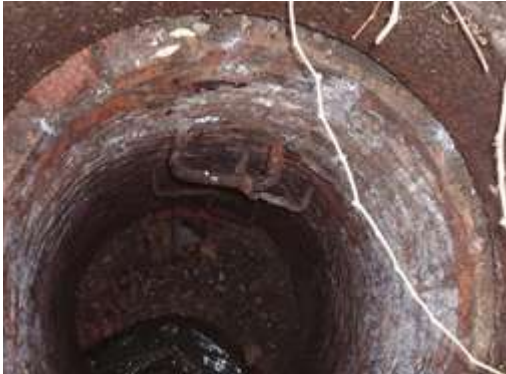
Defect

Frame leaks. Frame offset. Adjustment deterioration and infiltration. Barrel infiltration.

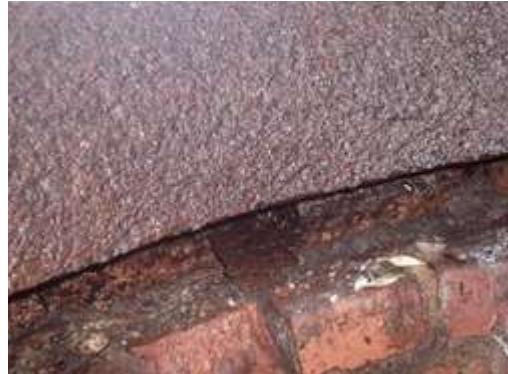
Defect

Frame leaks. Adjustment infiltration.

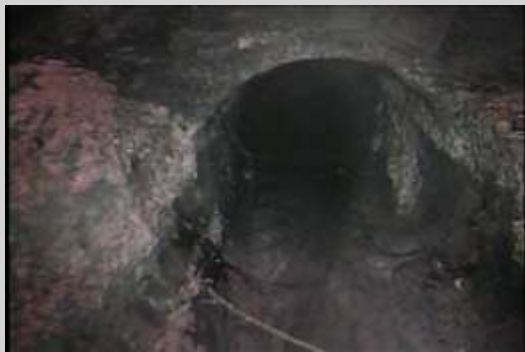
12 in. Circular Gravity Sewer Pipe Out @ 12 O'Clock

Deposits: ☐ None ☐ Mud ☐ Sludge ☐ Debris ☒ **Grease**

Silt Depth: **0** (in.) Deposits Extent: **Light**

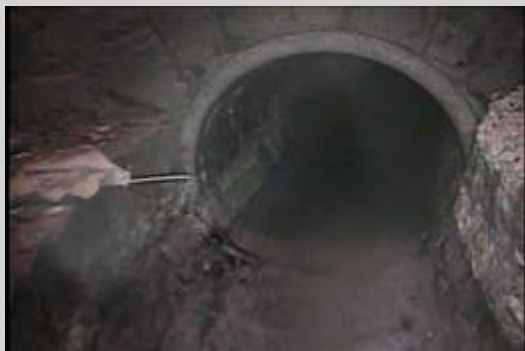
12 in. Circular Gravity Sewer Pipe In @ 9 O'Clock

Deposits: ☐ None ☐ Mud ☐ Sludge ☐ Debris ☒ **Grease**

Silt Depth: **0** (in.) Deposits Extent: **Light**
